Polyester over epoxy

**Applying
polyester
gelcoat to
WEST SYS-
TEM® epoxy
repairs made
BELOW the
water line**

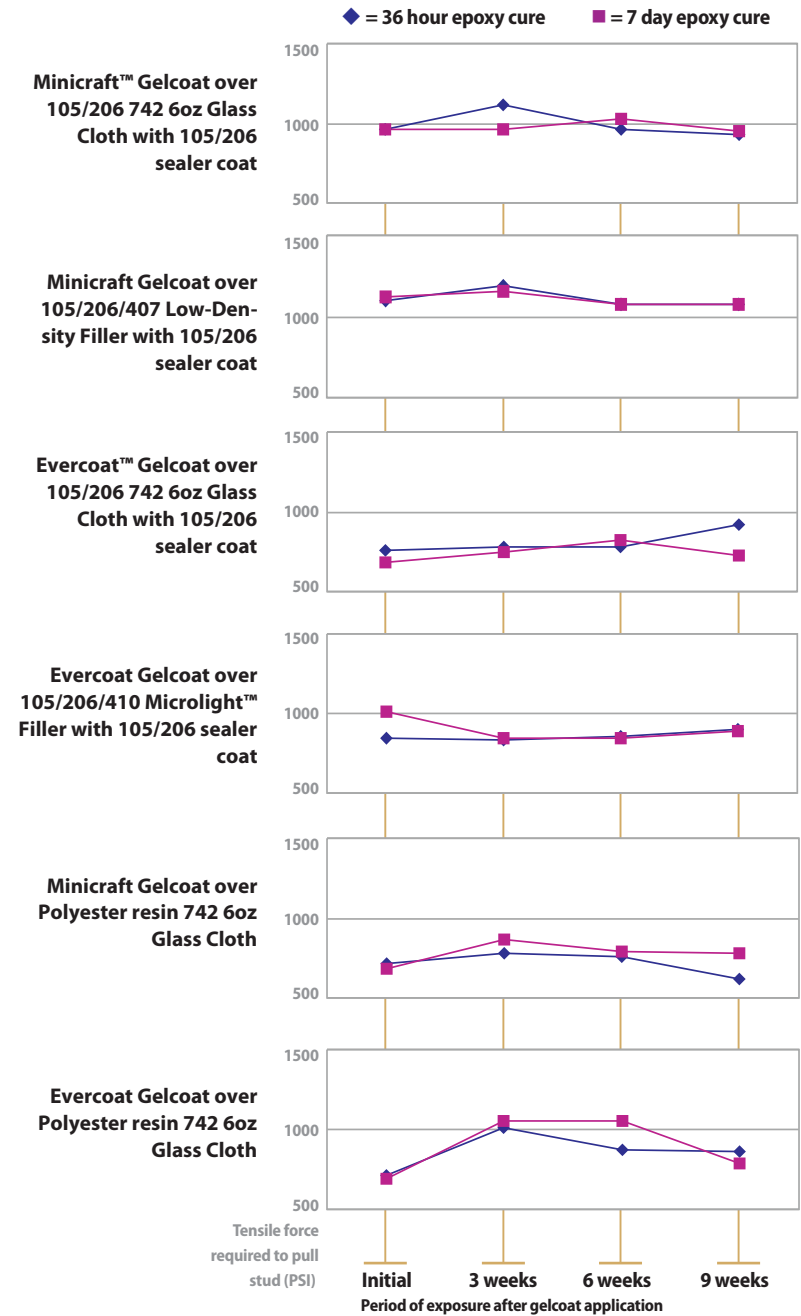
Figure 1
Gelcoat Adhesion Test

Graphs above show the trend of gelcoat bond strength at four time intervals. Each data point is the average tensile load required to pull studs from the surface of different material combinations that were sprayed with gelcoat.

Figure 1 (right) lists the different material combinations that were sprayed with gelcoat. The graph for each combination shows the tensile load required to pull the stud off the panel at four time intervals, illustrating the trend of the bond strength when the gelcoat is applied after allowing the laminate to cure for 36 hours and 7 days. Each data point represents the average of five stud pulls.

The overall effect of moisture on the gelcoat's bond to both the polyester and epoxy panels was negligible. The graphs show very little change in the adhesive strength, and much of the variance is within the tolerance of the test method. When the studs were pulled, the failures occurred in the fairing compound, cohesive failure of the gelcoat, or in the bond between the gelcoat and laminate. Since these three modes of failure occurred under similar loads, it indicates that the strength of the bond is close to the cohesive strength of both the gelcoat and the fairing compound. The
